Investigation Report

Department of Health

Clean Water Branch

Facility: City and County of Honolulu

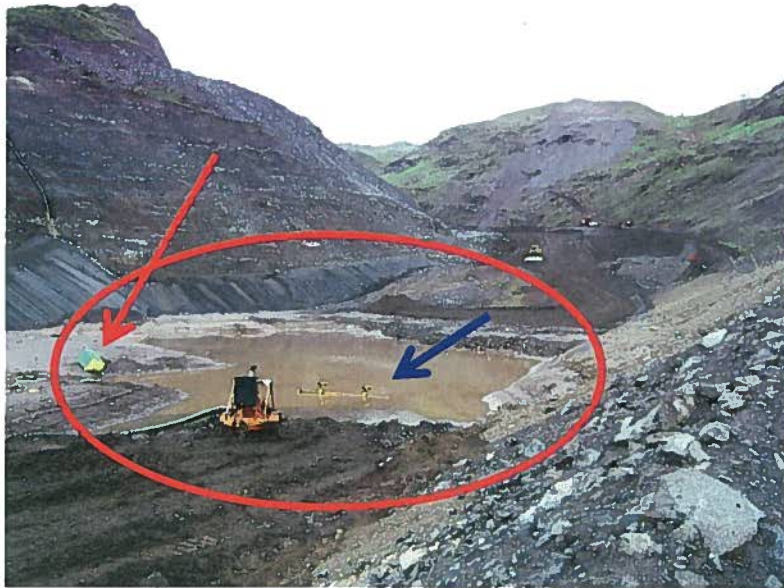
Photograph # 1

9) The Landfill's E6 cell (Photograph 1) was observed during the inspection. Ponding water was observed within the E6 cell. The E6 cell appeared to have been inundated by storm water as evidenced by high water marks observed on the sides of the cell. Significant amounts of exposed waste were not observed within the area upstream of the berm that bisects the E6 cell at the time of inspection. It appeared that the standing water saturated the E6 cell, and may have penetrated the leachate collection system while exposing solid waste which was buried in the cell.

10) In the North side of the E6 cell, an overturned porta-potty and a submerged piece of Landfill equipment was observed. The South side of the E6 cell, downstream of the berm (Photograph 2) was observed at the time of inspection. Significant amounts of exposed solid waste and refuse were observed within the area downstream of the berm in the E6 cell. The earthen berm which separated the E6 cell was damaged at the time of inspection. The DOH-CWB representatives observed a section of the intermediate cover had washed away,

Description: North facing view of the E6 cell upstream of the berm. Ponding water (Red Circle), an overturned porta-pottie (Red Arrow) and a submerged piece of equipment (Blue Arrow) was observed in the cell at the time of inspection.

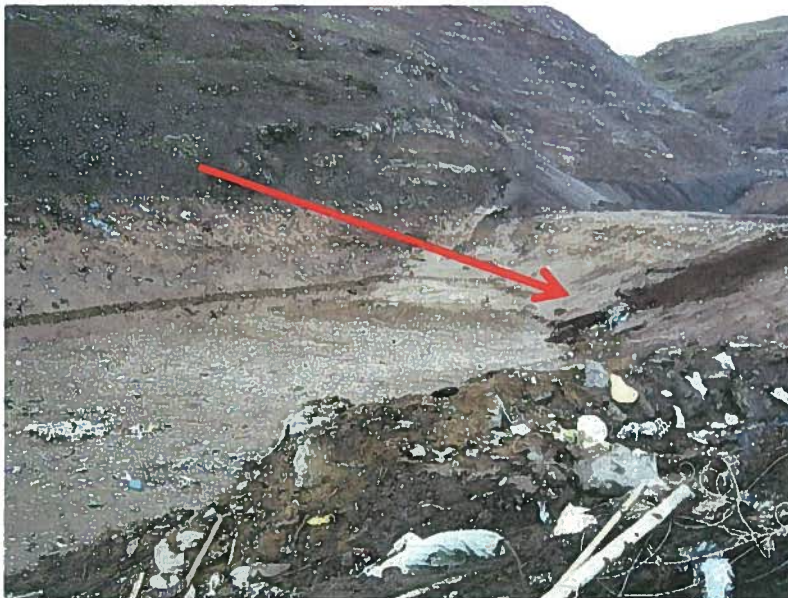
Photograph # 2

exposing solid waste from within the berm. The Landfill's contractor appeared nearly finished with covering the berm's exposed solid waste with new ground cover at the time of the inspection.

11) ☐ Where the ponding water was observed percolating through the solid waste downstream area of the E6 cell, a strong odor was detected by DOH-CWB representatives. The downstream area of the cell appeared significantly polluted with a mixture of solid waste and storm water.

Description: View facing North of the E6 cell downstream of the berm. The berm (Red Arrow) bisecting the E6 cell appeared to have ruptured and exposed solid waste was observed throughout the downstream side of the E6 cell. Goodfellow Brothers. was covering the exposed solid waste with soil in an apparent attempt to repair the berm damage at the time of inspection.

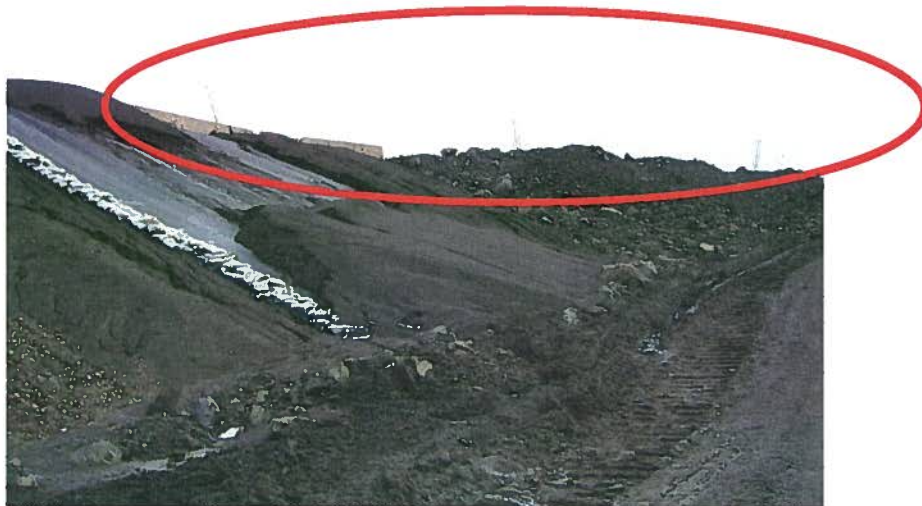
Photograph # 4

13) ☐ No windblown litter was observed in the upper E6 cell area or in the area surrounding the E6 cell. The nearby litter fences (Photograph 4) were clean at the time of inspection. The solid waste observed within the downstream area of the E6 cell did not appear to have blown in. The solid waste appeared to originate from the E6 cell.

Description: View of a litter fence (Red Circle) above the E6 cell. No windblown litter was observed accumulated in the litter fence at the time of inspection.

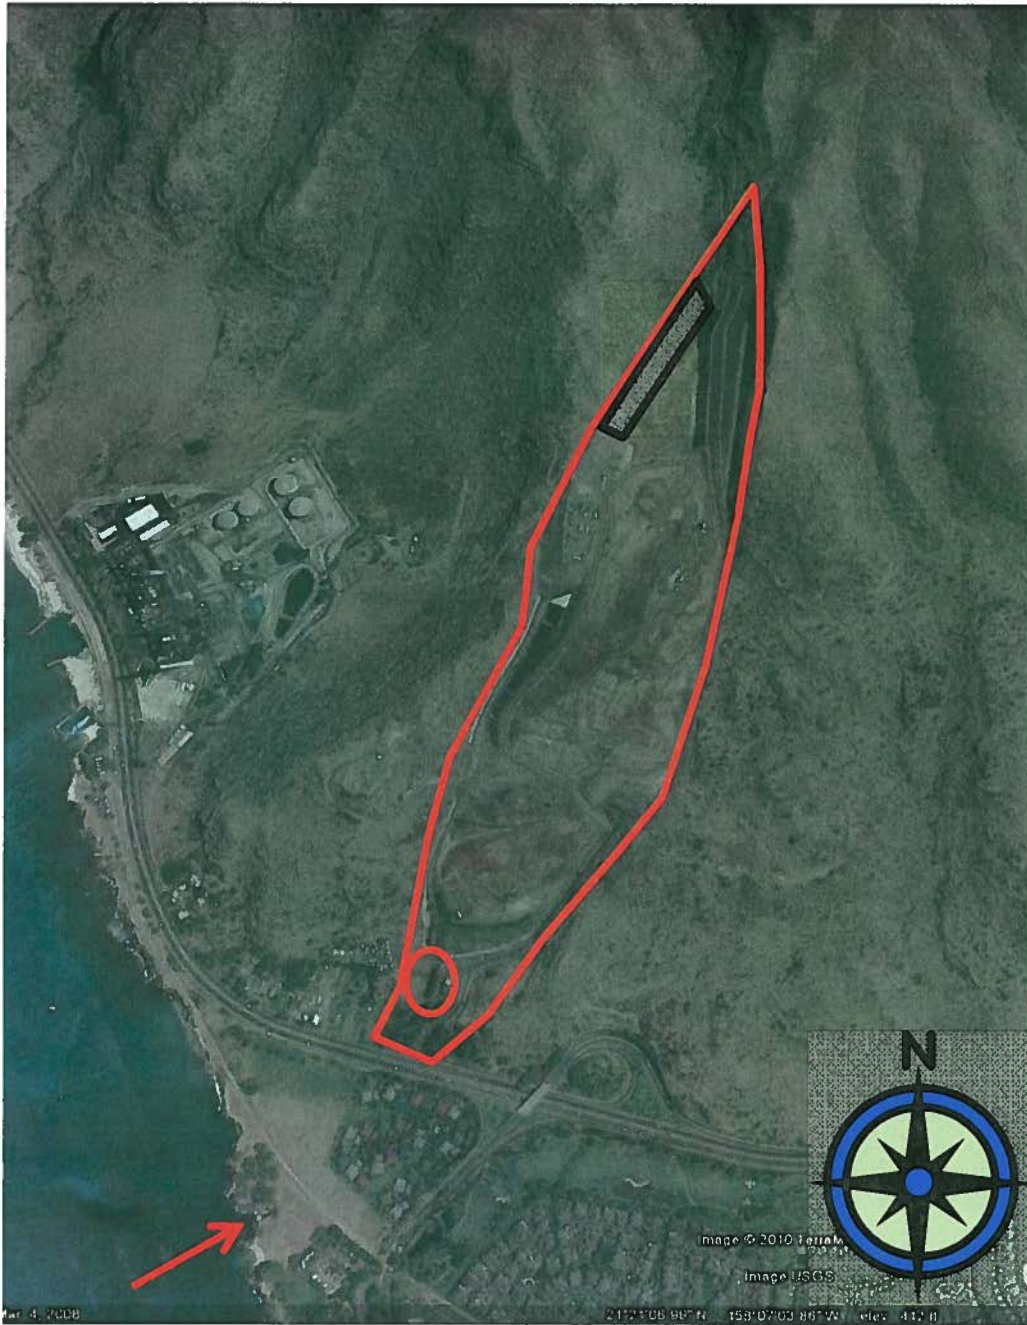
Image 1

Description: View of the Landfill (Red Outline). The E6 cell (Black Outline) was observed at the time of inspection. An earthen berm traversed the E6 cell. Discharges from the Landfill's storm water detention basin (Red Circle) enter into the Pacific Ocean at a shoreline outfall (Red Arrow) north of Ko Olina.
